Manhole Inspection Summary

Manhole # S13II1042MH

Location Address: **REAR- 3128 OAKFORD AVE**

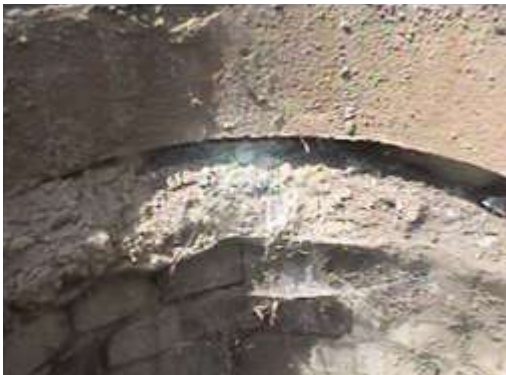
Defect 1

Condition: ☐ Sound ☐ Cracked ☐ Root Intrusion ☐ Loose Brick ☒ **Deteriorated**

Infiltration: ☐ None ☐ Joint ☒ **Cracks** ☐ Mortar ☐ Roots ☐ Wall

DETERIORATED ADJUSTMENT. WITH
POSSIBLE INFILTRATION- WEEPER

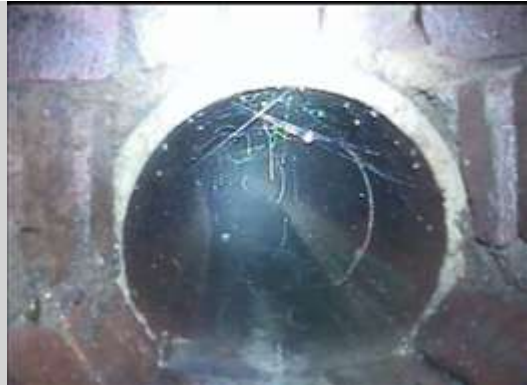
12 O'Clock Outflow

8 in. Circular Gravity Sewer
Pipe Out @ 12 O'Clock

Infiltration: **None** Pipe Seal Cond: **Sound**

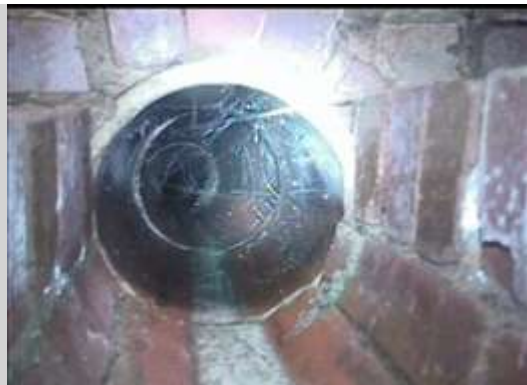
6 O'Clock Inflow

8 in. Circular Gravity Sewer
Pipe In @ 6 O'Clock

Infiltration: **None** Pipe Seal Cond: **Sound**

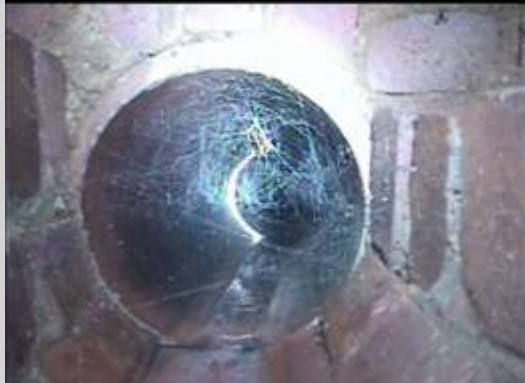
9 O'Clock Inflow

Pipe In @ 9 O'Clock

Infiltration: **None** Pipe Seal Cond: **Sound**
